Behaviour of Prefabricated Timber Wall Elements Under Static and Cyclic Loading

Patrick Schädle, Hans Joachim Blaß

Lehrstuhl für Ingenieurholzbau und Baukonstruktionen

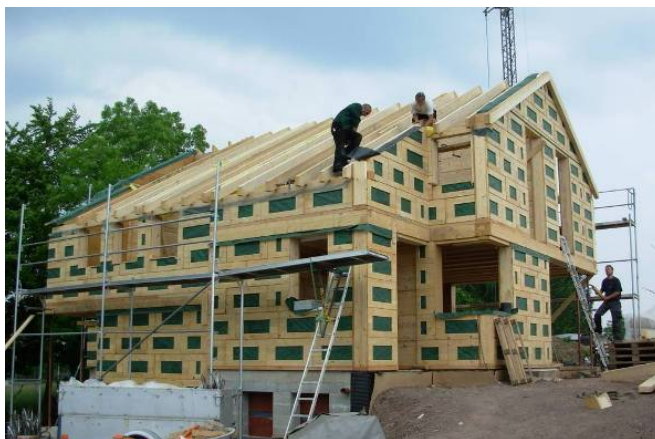
Fig. 1 Building made of Prefabricated Timber Wall Elements

The main feature of PFTE is pre-fabricating wooden “brick” elements primarily out of the residues of a saw-mill. The brick-like elements can be easily transported to the building site and are easy to handle even for beginners under the guidance of a site foreman. The mass of a single element is less than 25 kg, it can be moved by hand and walls can be built without a crane. Thus the system can be cost-saving. In Germany a technical approval for up to three - storey buildings was issued in Sept. 2007.

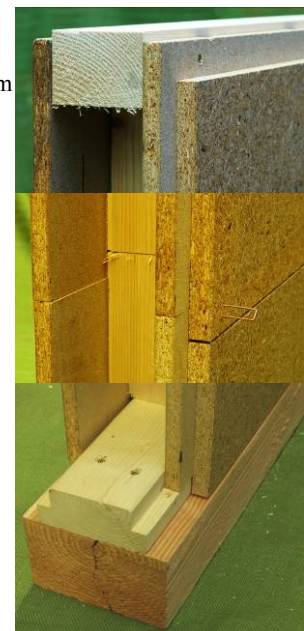
Fig. 4 Details of Prefabricated Timber Wall Element System

Top rail on top element, fixed with:
 -vertical screw 6 x 140 mm every 2nd column
 -Horizontal screw 5 x 60 mm – spaced 250 mm solely on chipboard side
 -Horizontal staples 64 mm – dist. 50 mm solely on chipboard side

Basic elements, overlap connected with staples 32 mm – spaced 50 mm solely on chipboard side

-Douglas fir wall plate with spruce element, connected via screws 6 x 160 mm spaced 250 mm
 -First line connected to spruce element via 1 BMF-Angle per wall element
 -First-Line elements connected with staples 64 mm – spaced 50 mm solely on chipboard side

a wall plate is fixed to the foundation. The first row of the elements is installed by fixing each element to the wall plate via one BMF 90 x 90 mm angle connector. When the wall height is reached, a continuous vertical stud is inserted from the top at least every 3 m of wall length. The vertical studs transfer the in-plane up-lift forces to the foundation, and

they provide bending stiffness for loads perpendicular to the wall plane, e.g. wind loads. At the top of the wall the top rail is put into position and the vertical studs as well as the top rail are connected to the elements via self-drilling screws. Normally the spaces between the vertical columns are filled with insulation. The tests, however, were performed without insulation. All the connections described in Fig. 4 are of prime importance for the behaviour of the wall under the different loading conditions.

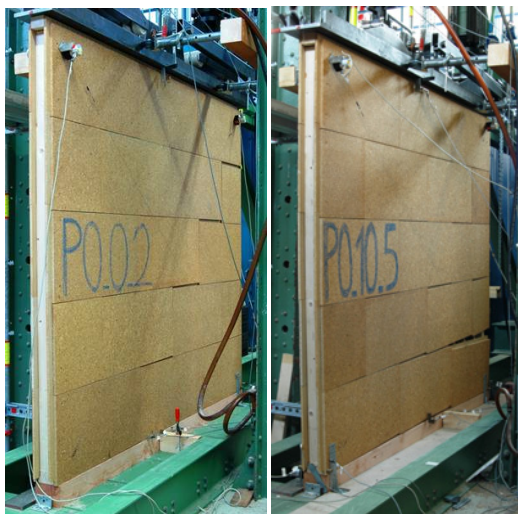
Fig. 9 Test Wall Specimen after test

of changed boundary conditions between the two cases. While the wall without additional vertical load shows restricted rocking behaviour [1], the shear deformations of the wall turn out to be rocking behaviour [1] until failure of the test specimen was reached by the staples in the horizontal joints being pulled (see Fig. 9 on the right).
